## Disturbance diagrams captured by Sipronika LOK 200

**Devices: Sipronika LOK 200**
**Location: xxx**

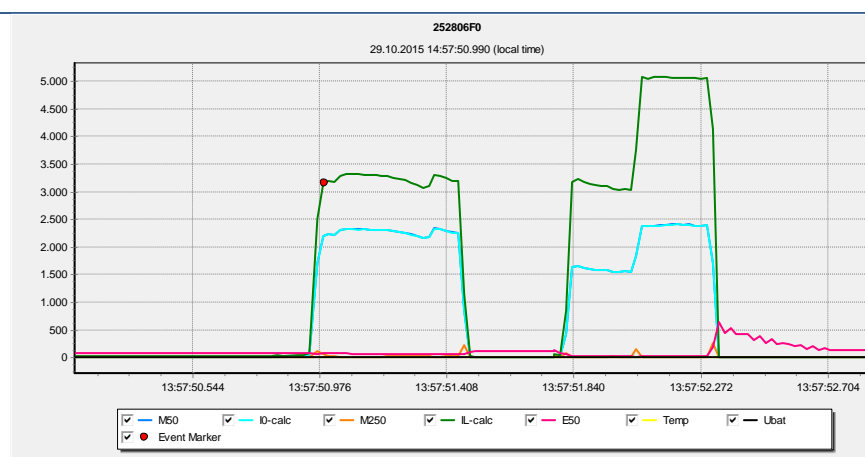
**Indicator: 252806F0**

1. Phase-to-phase short circuit behind indicator
2. At the end of the fault can be seen the rise of E50 (red curve) presence of residual voltage  $U_0$
3. After 60 s was successful automatic reclosing (not on this chart). The device correctly detected Transient fault type.

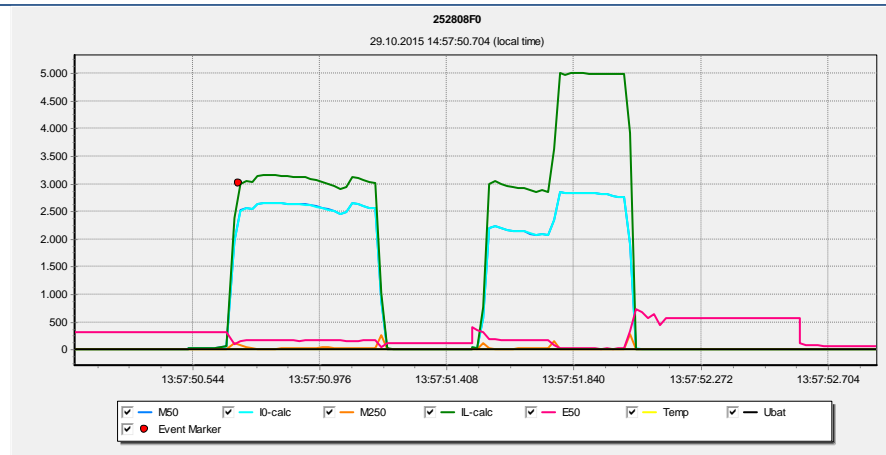
### Indicator: 252808F0

1. Phase-to-phase short circuit behind indicator
2. At the end of the fault can be seen the rise of E50 (red curve) presence of residual voltage U0
3. After 60 s was successful automatic reclosing (not on this chart). The device correctly detected Transient fault type.

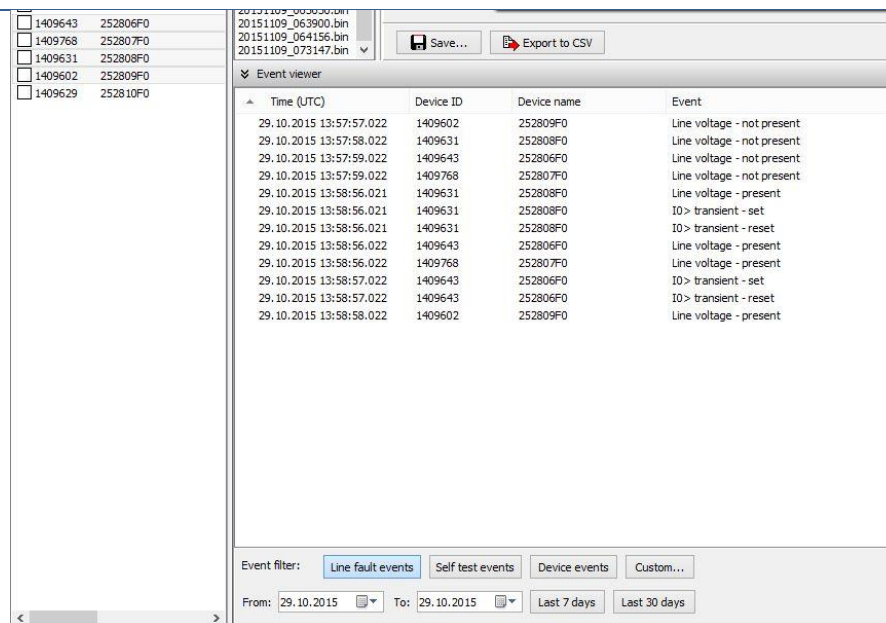
### Event log for 29.10.2015

1. Screenshot of Event log for indicators 252806F0, 252807F0, 252808F0 and 252809F0
2. Events were downloaded from device's local memory
3. All indicators detected events on 29.10.2015 as expected.

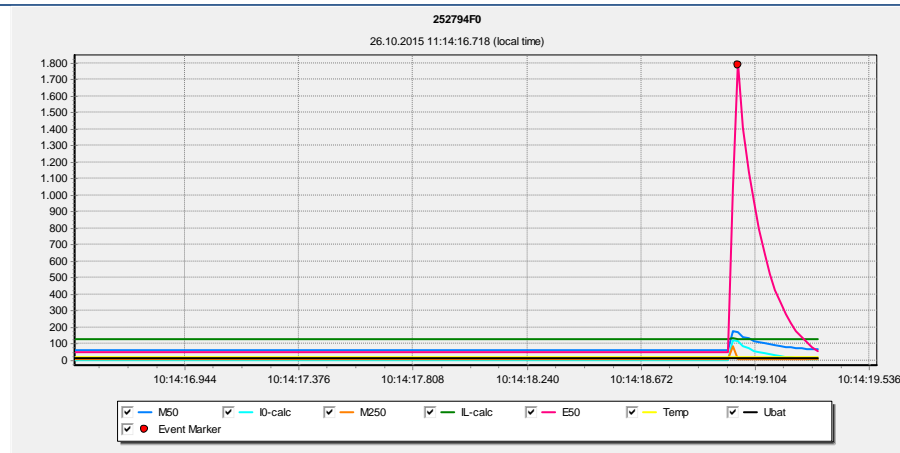
**Indicator: 252794F0**

1. Breakdown to the ground on 26.10.2015 @10:14:19 UTC (12:14:19 local time) in duration of one cycle.
2. Event has been "seen" by all devices in the network – increase of E50 and one cycle increase of I0.
